# Inspection Report

**Property Address:**  
Sample Report  
Holly Springs NC

**Jeff Pinyoun Residential & Commercial Inspections**

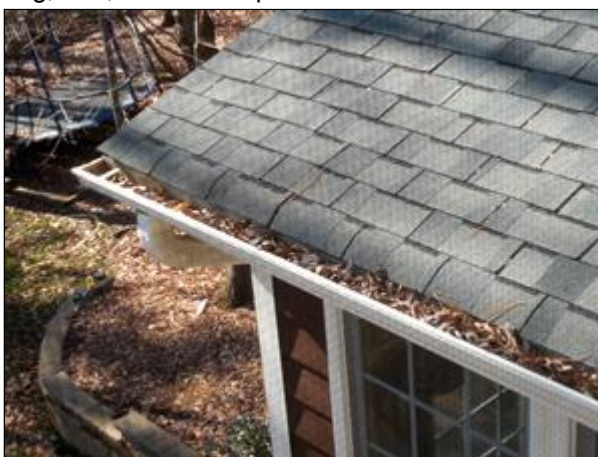
1.1 Picture 1

**1.1 Maintenance** The gutters were full of leaves and debris at the time of inspection -see example picture 1 below. Gutters should be cleaned on a regular basis to prevent blockage which causes water to overflow the gutters leading to possible moisture damage to the siding, trim, and crawl space.

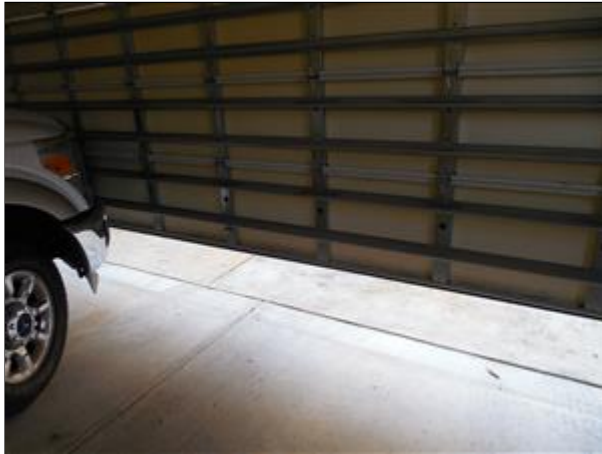
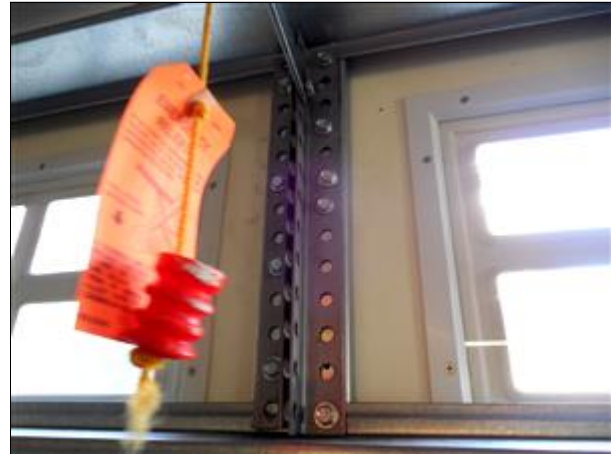
**3.5 Repair** The following electric garage door opener defects were noted: (A.) The garage door opener did not reverse when the electric eyes light beam was interrupted or when resistance was applied to the door during the close mode (the door just stops at the position it is in when interrupted) -see example picture 1 below. The door should be repaired such that it reverses when the eyes are interrupted and when the proper amount of resistance is placed on the door. (B.) The door makes uneven/"jerking" movements when being raised. Note: Partial repairs vs panel replacement have been performed on the upper panel of the door where the lifting brackets attach to the door -see picture 2 below. The door should be properly repaired such that it functions as intended during operation. (C.) The light on the electric opener did not flash when interrupted or when resistance was placed on the door and sporadically operated when activated by the

light switch on the opener control pad on the wall. The opener light should be repaired such that it functions as intended during operation or when activated.

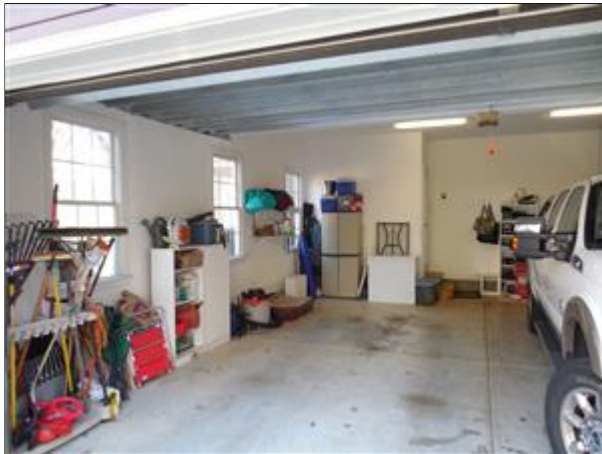
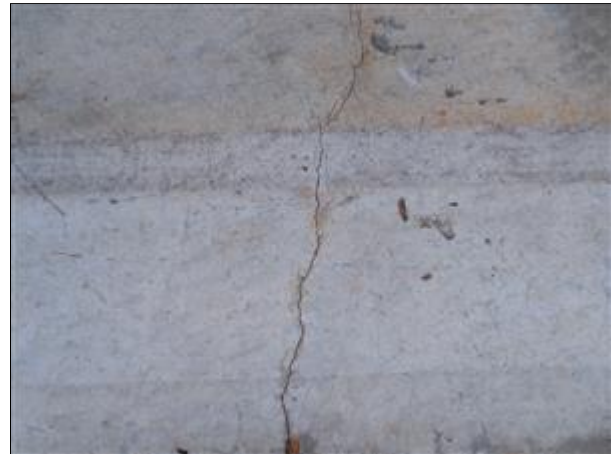
**3.6 Comment** The following observations were noted with the garage area: (A.) Areas of the garage could not be inspected due to the storage of personal belongings -see example picture 1 below. This should be done once the belongings are removed. (B.) Cracks in the poured concrete foundation slab of the garage were noted -see example picture 2 below. These cracks are less than a quarter of an inch in width and are not pitching and heaving. These cracks do not appear to require repair for functional purposes and in most cases cracks such as these are stable and do not significantly change once a house has reached this age. In all cases I can not predict nor guarantee against future changes which might require repair.

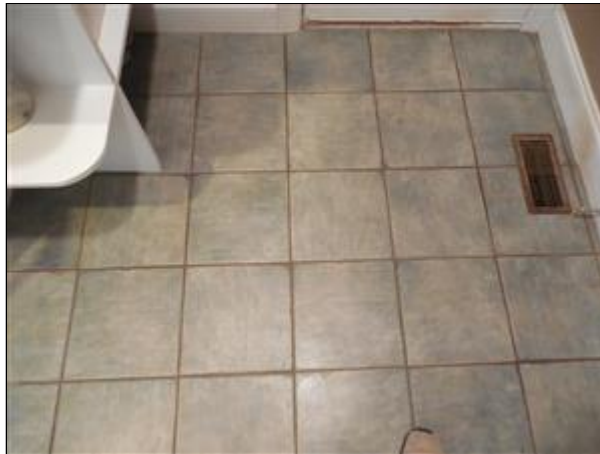
4.2 Picture 1

**4.2 Repair** Loose/detached floor tiles/grout were noted on the mid-portion of the first floor mud room floor -see picture 1 below. All loose/detached floor tiles/grout should be properly resecured.

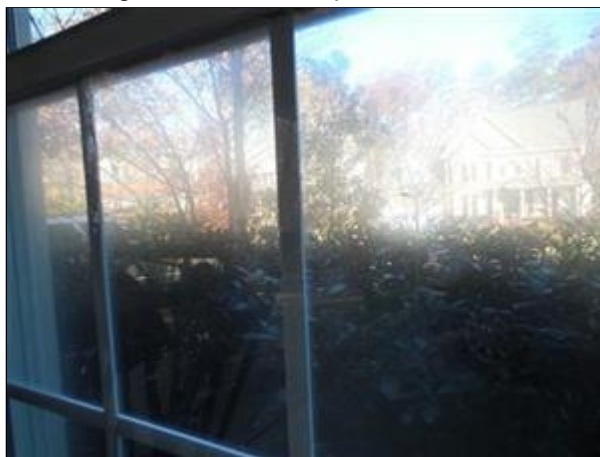
4.6 Picture 1

**4.6 (1) Repair** The insulating window seals have failed resulting in debris and/or moisture between the panes of the lower sash of the far right front garage window -see picture 1 below. Window units with failed seals do not function as intended and require replacement. The sash glass should be replaced.

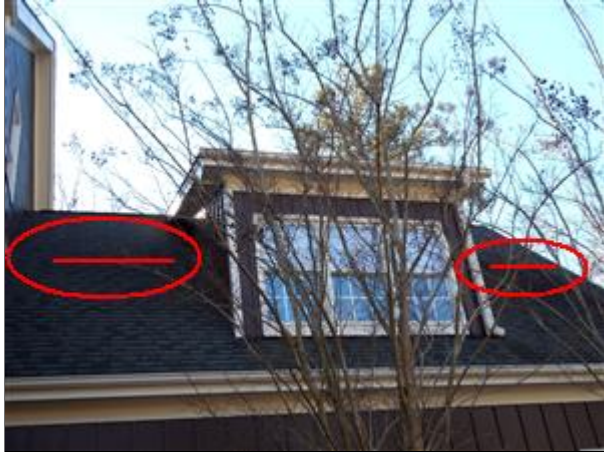
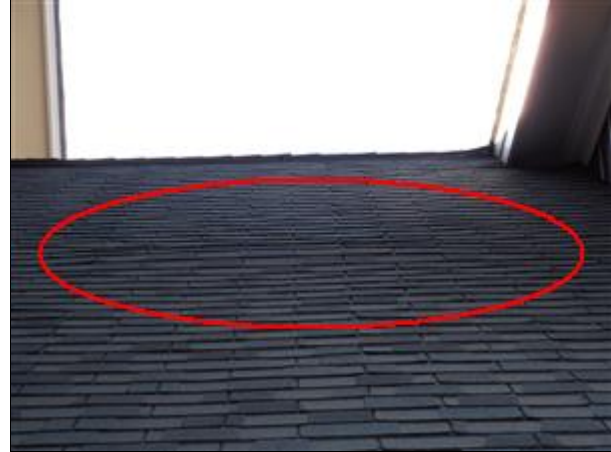
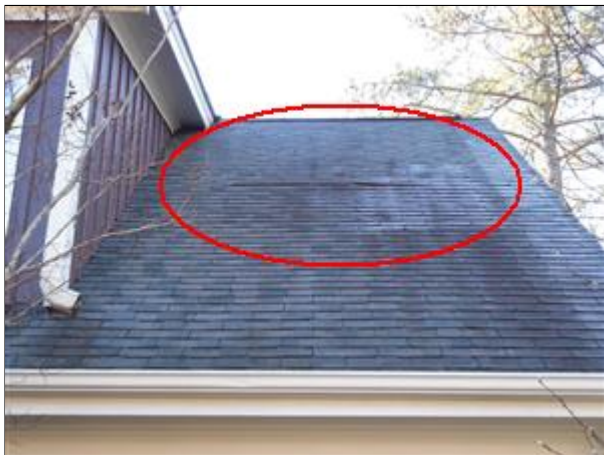
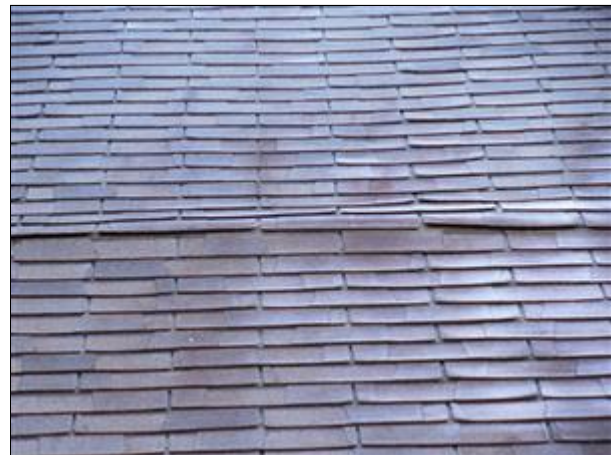
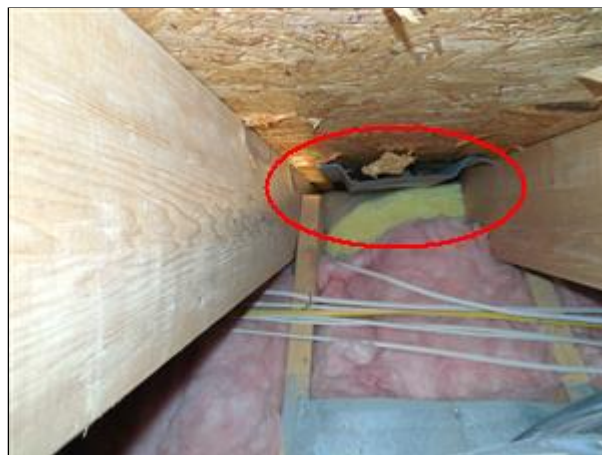
**5.5 Repair** Raised/damaged OSB roof sheathing was noted at the mid-left of the front dormer on the garage roof - see pictures 1 & 2 below, and of particular note to the mid-right of the front dormer on the garage roof -see pictures 1, 3 & 4 below. A further evaluation of these areas in the attic revealed raised/detached/damaged OSB roof sheathing -see example picture 5 below. The source of the raised/detached/damaged roof sheathing should be determined and corrected by a licensed contractor experienced in such. All damaged structural materials as well as all roofing materials should be replaced in their entirety.

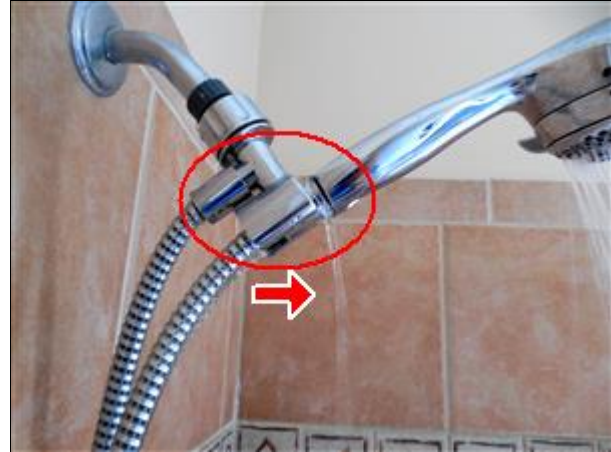
6.0 Picture 2

(C.) The master bathroom hand held shower head/hose leaks at the connections beneath the handle -see example picture 2 below. The shower head/hose should be properly repaired or replaced with a like style head/hose.

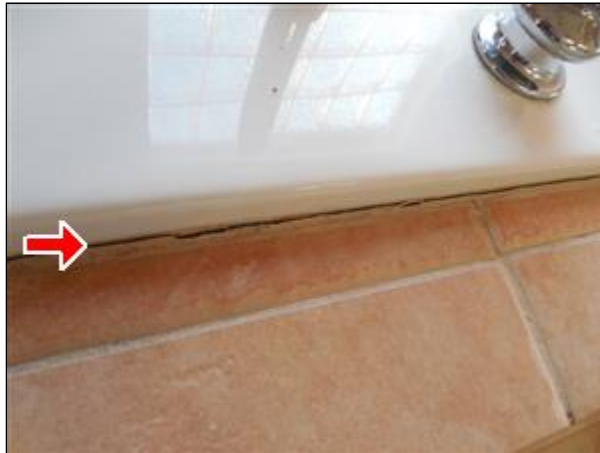
6.0 Picture 3

(2) **Maintenance** The grout/caulk/sealant has failed at the upper bathtub/bathtub surround -see example picture 3 below. The grout/caulk/sealant should be renewed to prevent moisture penetration at these areas.

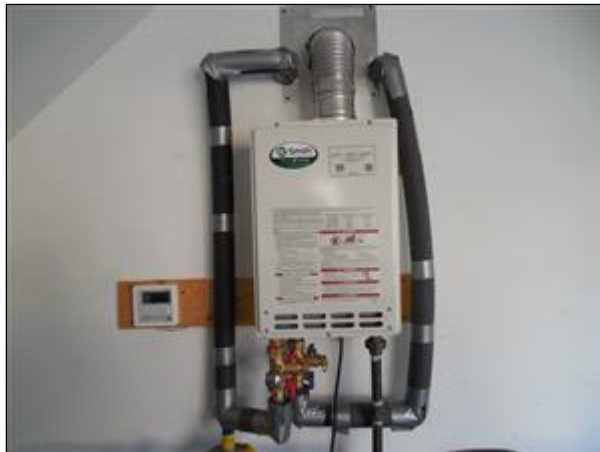
6.2 Picture 1

**6.2 Comment** The temperature of the hot water is 104 degrees F. The water heater is located in the garage area -see picture 1 below.

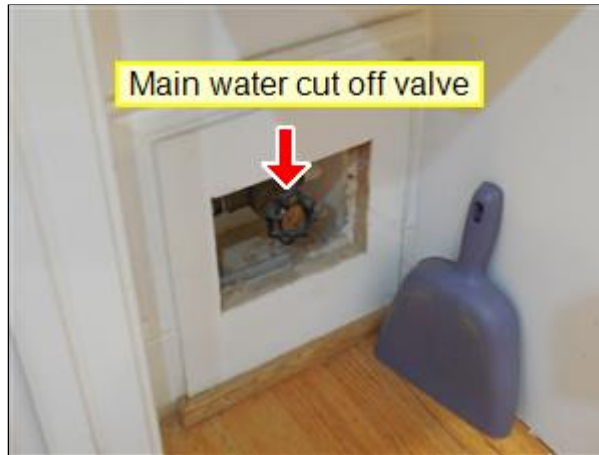
6.3 Picture 1

**6.3 Comment** The main water cut off valve is located in the kitchen pantry -see picture 1 below.

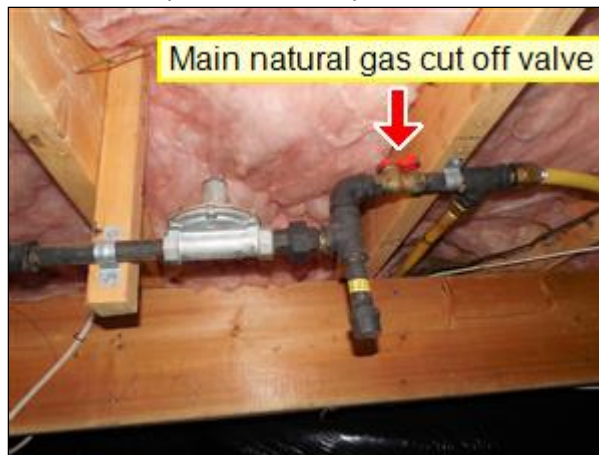
6.5 Picture 1

**6.5 Comment** The main natural gas fuel shut off valves are located at the natural gas meter outside and at the regulator/gas lines connection area in the crawl space area -see picture 1 below.

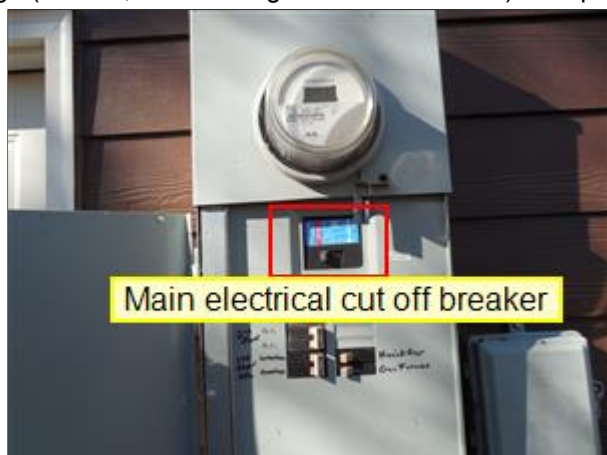
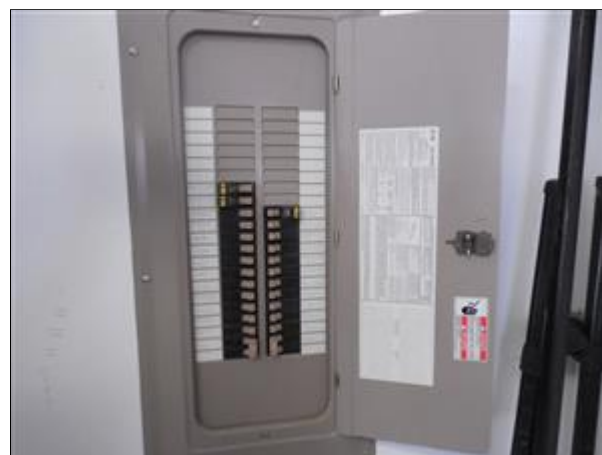
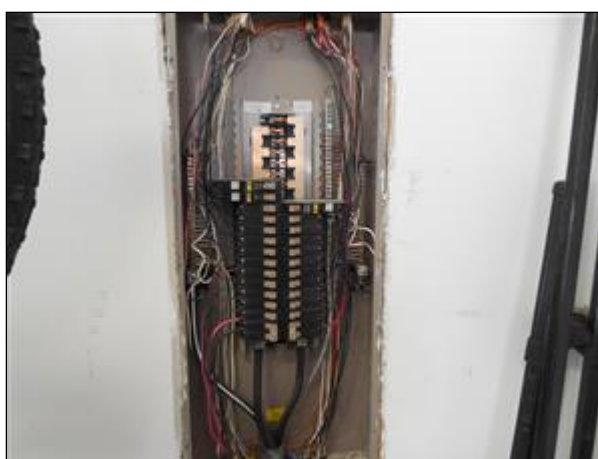
**7.1 Comment** The main electrical panel is located beneath the electric meter at the left side of the home -see picture 1 below. Note: The one electrical circuit breaker turns off all of the power to the home. The electrical sub-panel is located in the garage (smaller, lower voltage individual circuits) -see pictures 2 & 3 below.

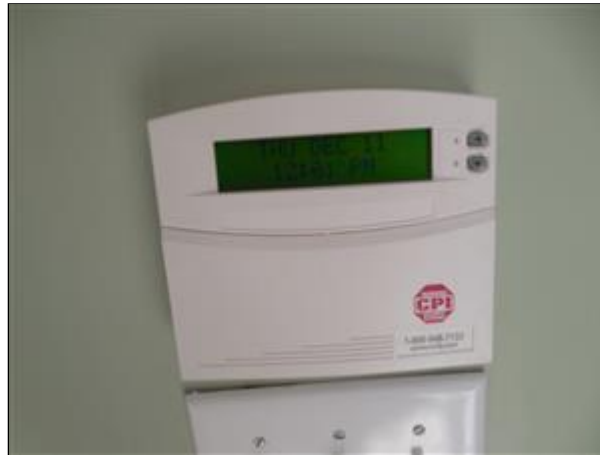
7.9 Picture 1

**7.9 Comment** The security system, satellite/cable TV reception systems, telephone systems along with other low voltage systems were not inspected or tested as this is not considered part of a normal home inspection -see example picture 1 below. Consult the seller or providers for any documentation and demonstrations.

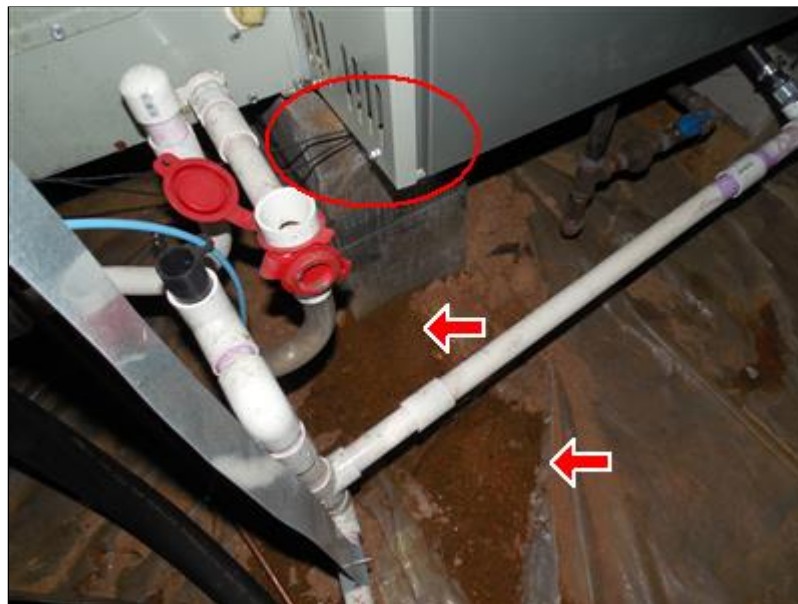
8.0 Picture 1

**8.0 Repair** High efficiency furnace condensate (brine) was noted leaking from the front left of the first floor air handler/furnace case during operation -see picture 1 below. Puddled condensate/brine was noted on the dirt crawl space floor beneath the air handler -also see picture 1 below. The source of the leakage should be determined and corrected as needed by a licensed HVAC technician.

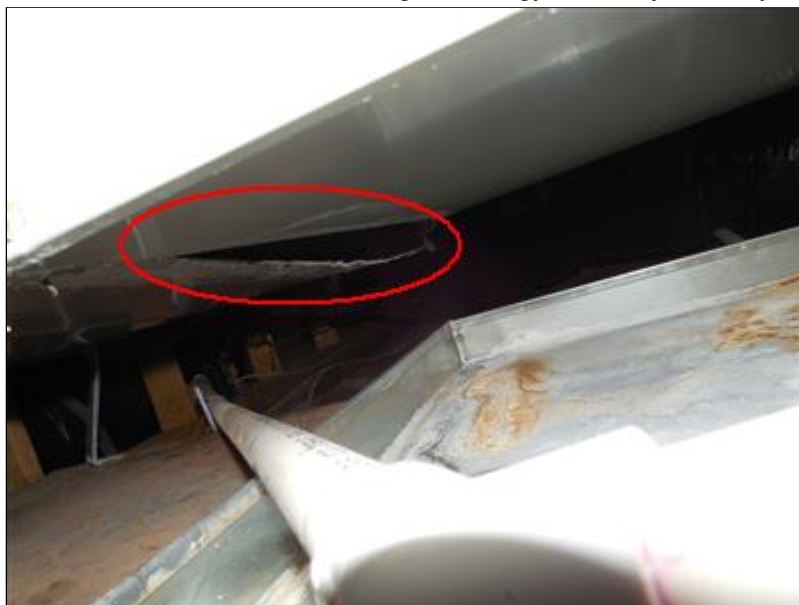
8.3 Picture 1

**8.3 (1) Repair** Conditioned air was noted escaping from the exterior base of the HVAC air handler in the attic area. A further evaluation revealed open voids/seams on the case -see example picture 1 below. The seams/voids should be sealed by a licensed HVAC technician to assist in maintaining the energy efficiency of the system.

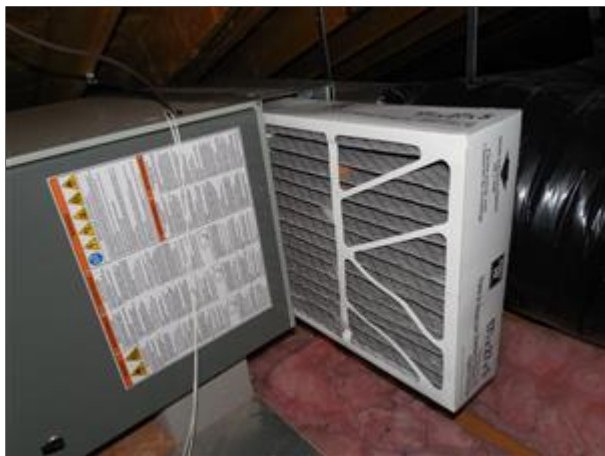
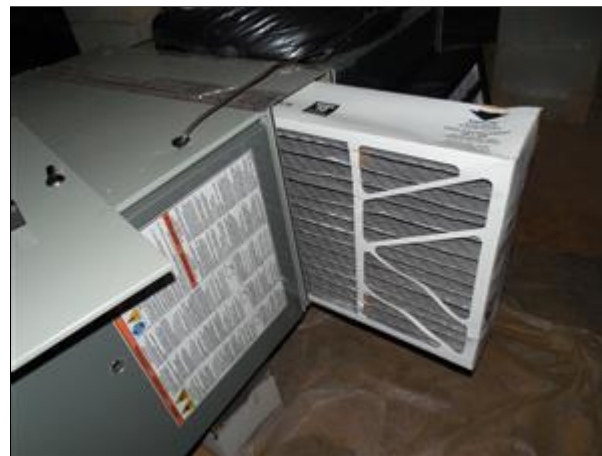
**(2) Maintenance** Both air handlers are equipped with large "box" style air filters -see pictures 2 & 3 below. These filters are presently dirty and like conventional style air filters need to be changed on a regular basis. The size of these filters are: 17 & 1/2" x 27" x 5".

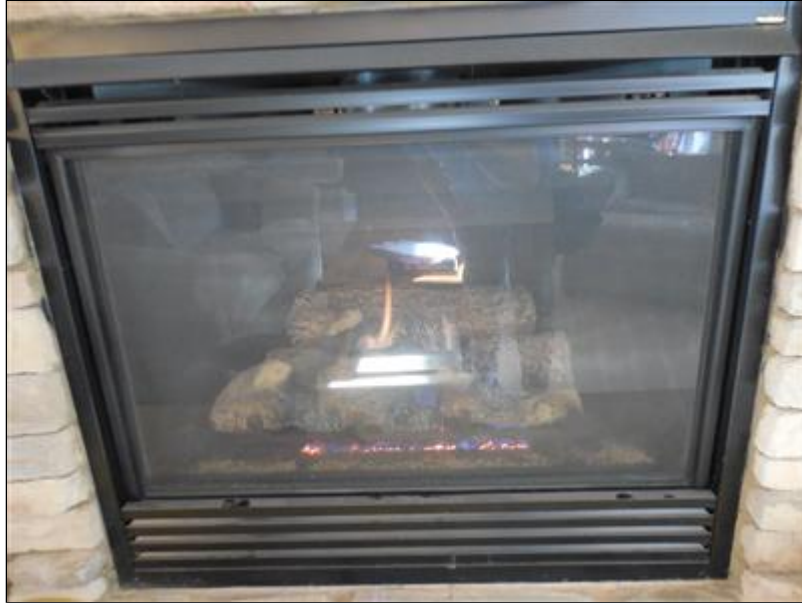
8.6 Picture 1

**8.6 Comment** The gas log fireplace was operated and was found to be functional -see picture 1 below. Please follow the manufacturers operating instructions and install carbon monoxide detectors, especially in the bedrooms.

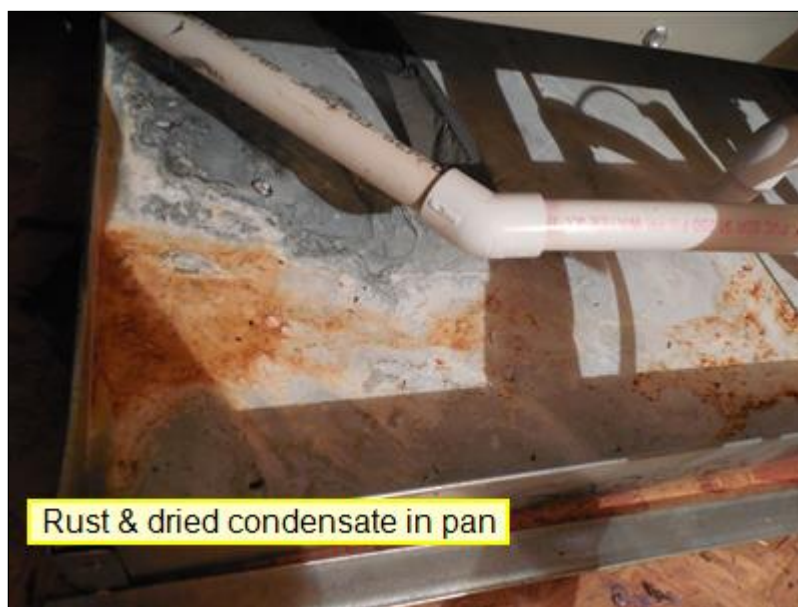
8.7 Picture 1

**8.7 (1) Investigate Further** The following observations were noted with the HVAC systems: (A.) The auxiliary drain pan located below the air handler in the attic has a coating of dried condensate and rust -see example picture 1 below. This is not normal and may indicate a problem. The primary drain system is located inside the air handler. The system drains away the condensate water removed from the air by the normal operation of the air conditioning system. Dried condensate and rust in the auxiliary pan suggests that the main drain (primary drain) has at some time in the past been restricted/clogged or there has been a leak in the primary drain system. Due to not being able to operate the air conditioning portion of the HVAC system I could not determine if this is an active problem or one that has been corrected. A licensed HVAC technician should make a further inspection and repair as needed or records of a prior repair by a licensed HVAC technician should be provided. (B.) Both HVAC systems are not original to the home (2011 build). It appears the coded information on the information plates on the HVAC components states the systems are two three ton systems (Model # 4Twx6036E1000AA). There are various ways to calculate the proper size HVAC system(s) for a home and this should be left to a licensed HVAC contractor, however one common way is tonnage per "heated" square feet of the home. Per calculations for the size of this home (3206 heated square feet, less per county records), this system could be too large for the home (normal calculations for this age home suggest roughly 650 - 700 heated square feet per ton). The system should be further evaluated by the licensed HVAC installation contractor for proper sizing and installation and repaired/replaced as needed. In addition, the load calculation documentation should be given to and explained to the home buyers.

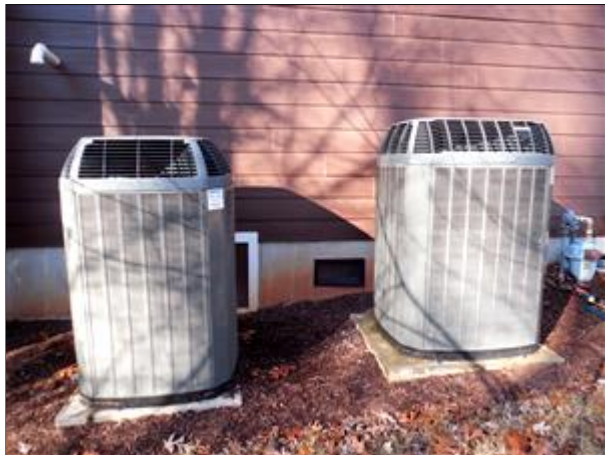
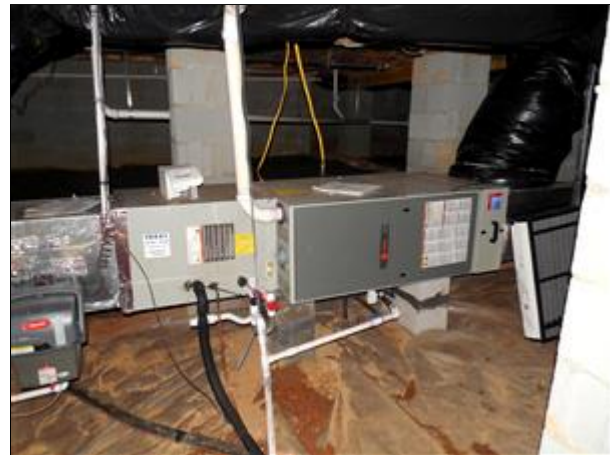
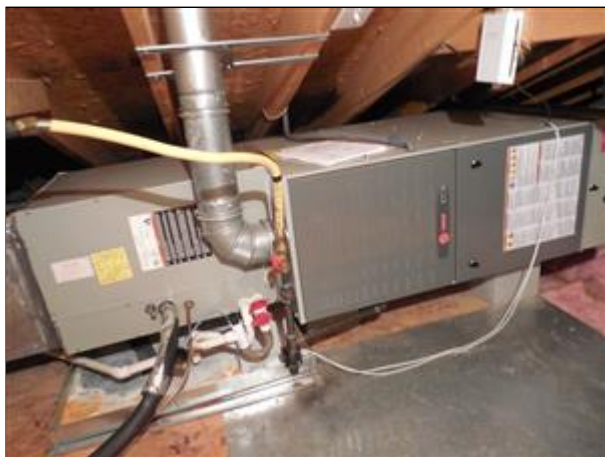
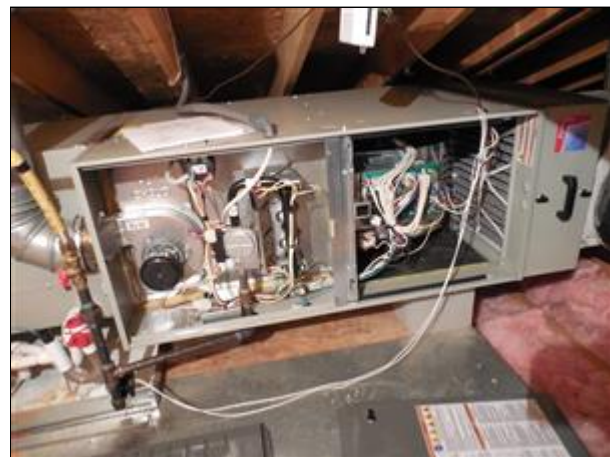
**8.10 (1) Comment** Per coded information on the HVAC system(s) they appear to be: (2.) 2011 Trane 3 Ton Systems - see pictures 1-4 below.

Compressor Model Number: 4TWX3036E1000AA Serial Numbers: 11261KX91F & 11025UC72F

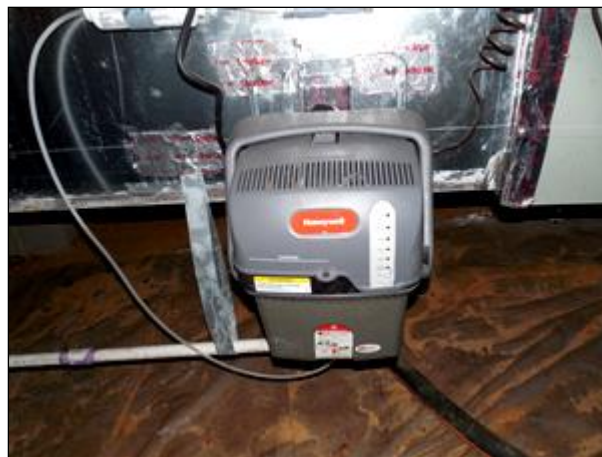
8.10 Picture 5

(2) **Comment** The humidifier/dehumidifier on the first floor HVAC system was not inspected or tested as this is not considered part of a normal home inspection -see picture 5 below. Consult the seller or manufacturer for more information and/or a demonstration.

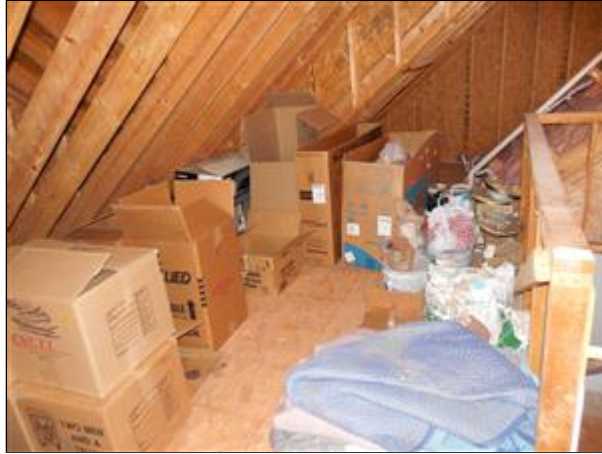
9.0 Picture 1

**9.0 Comment** Areas of the attic could not be properly inspected due to the storage of personal items -see example picture 1 below. This should be done once the items are removed.

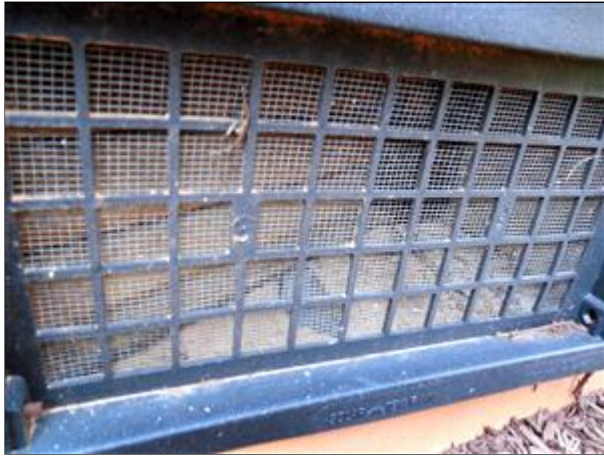
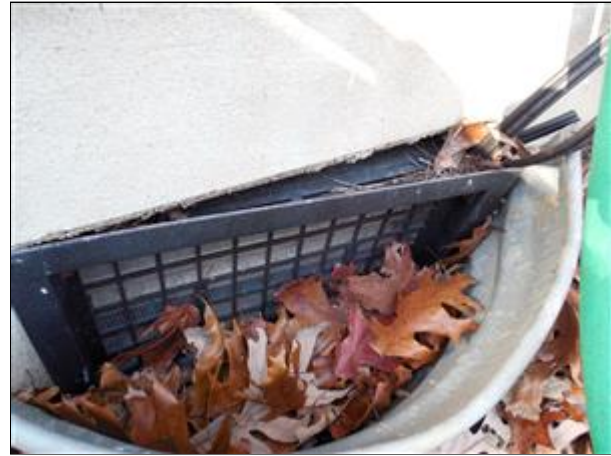
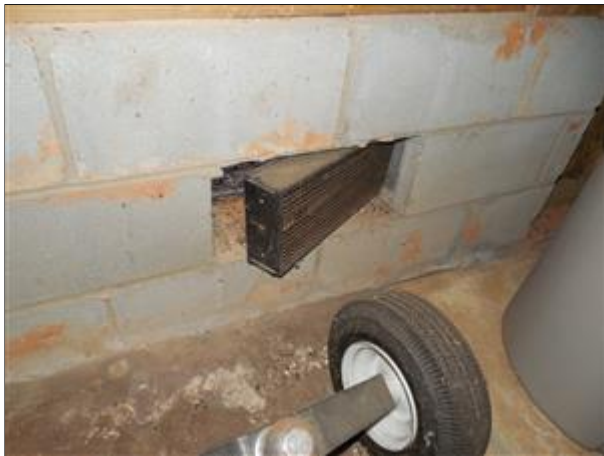
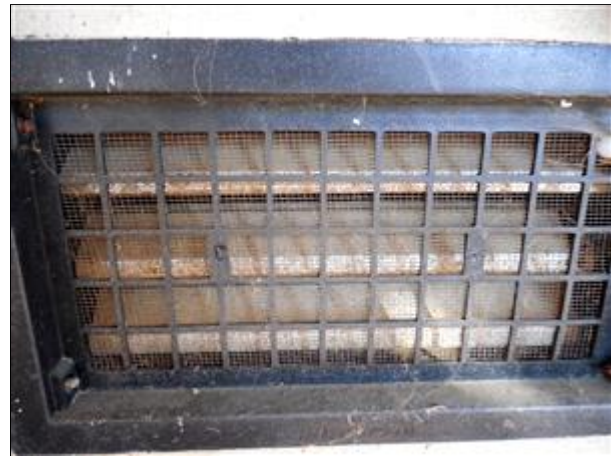
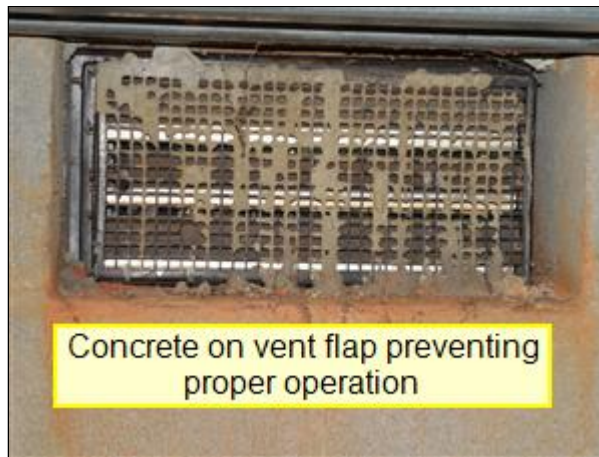
**9.1 (1) Repair** The following auto-foundation vent defects were noted: (A.) The auto-foundation vent at the front of the left side of the home and the second to the front foundation vent on the left side of the home are damaged preventing their proper operation -see pictures 1, 2 & 3 below. The vents should be replaced with like style auto-vents to properly assist in the regulation of the temperature, moisture and fresh air into the crawl space area. (B.) Various automatic foundation vents on all sides of the home including the front porch were not open with temperatures in the thirties at the time of inspection -see example pictures 4 & 5 below. Automatic foundation vents automatically open their vent flaps when temperatures reaches a certain degrees, normally above forty degrees F and subsequently close when temperatures fall below forty degrees F. This is achieved by a coiled spring on the side of the vent that functions like a thermostat. All of the foundation vents should be evaluated for proper functionality and replaced as needed.

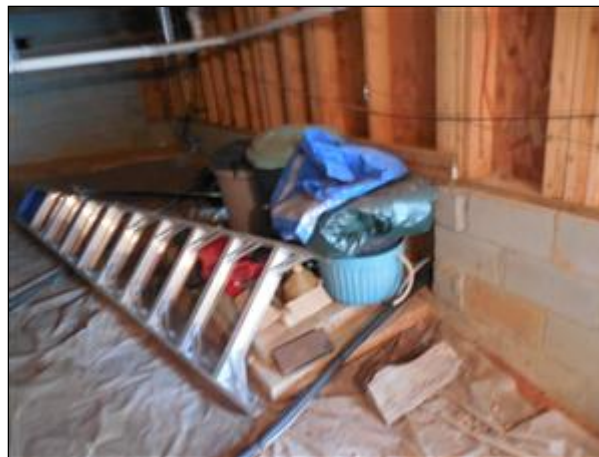
9.1 Picture 6

(2) **Comment** Areas of the crawl space could not be inspected due to the storage of personal belongings -see example picture 6 below. This should be done once the belongings are removed.
