Inspection Report

Property Address:
Sample Report
Raleigh NC 27614

The _____ Residence

Jeff Pinyoun Residential & Commercial Inspections

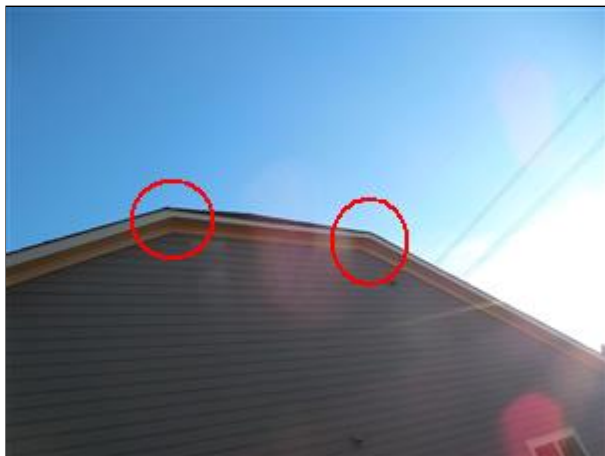
1.0 Picture 1

**Repair** The end ridge cap shingles are damaged at the lower base of the upper hip roof seams on the right side of the home -see pictures 1, 2 & 3 below. All damaged shingles should be replaced in their entirety, not patched or tared as this is considered a temporary repair that also voids the manufacturer's warranty. All roof repairs should be performed by qualified roof contractors.

1.0 Repair The end ridge cap shingles are damaged at the lower base of the upper hip roof seams on the right side of the home -see pictures 1, 2 & 3 below. All damaged shingles should be replaced in their entirety, not patched or tared as this is considered a temporary repair that also voids the manufacturer's warranty. All roof repairs should be performed by qualified roof contractors.

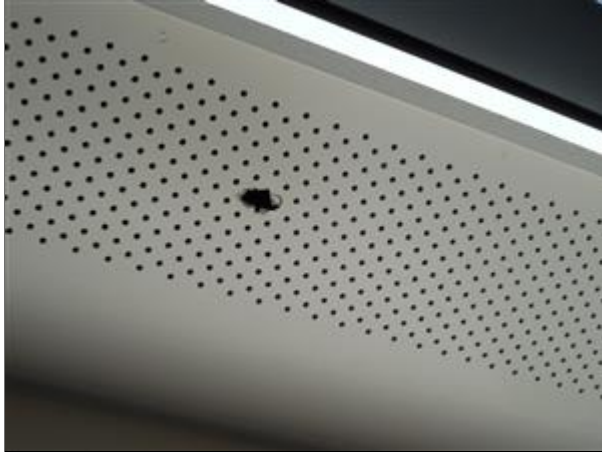
2.0 Picture 1

**Repair** The following exterior siding and trim defects were noted: (A.) The soffit is damaged at the rear patio -see picture 1 below. All damaged materials should be replaced in their entirety, primed and painted. (B.) The wood ceiling is damaged around the rear patio ceiling fan -see picture 2 below. All damaged materials should be replaced, primed and painted. (C.) Caulk is lacking at the upper exterior garage door trim/fiber cement siding on the right side -see picture 3 below. Calk should be replaced, primed and painted where lacking. (D.) Excess house wrap was noted beneath the siding on the lower mid-right side of the home -see example picture 4 below. All excess house wrap should be removed. (E.) Sealant is lacking around the HVAC condensate drain pipes at the lower right side -see pictures 4, 5 & 6 below. Sealant should be applied where needed. (E.) Debris was noted in the upper wall hood on the right side of the home -see picture 7 below. The debris should be removed and hood confirmed functional. (F.) Paint over-spray was noted on the first floor front porch window -see example picture 8 below. All excessive paint should be removed without damaging the window or the damaged window materials should be replaced.

2.0 Repair The following exterior siding and trim defects were noted: (A.) The soffit is damaged at the rear patio - see picture 1 below. All damaged materials should be replaced in their entirety, primed and painted. (B.) The wood ceiling is damaged around the rear patio ceiling fan -see picture 2 below. All damaged materials should be replaced, primed and painted. (C.) Caulk is lacking at the upper exterior garage door trim/fiber cement siding on the right side -see picture 3 below. Calk should be replaced, primed and painted where lacking. (D.) Excess house wrap was noted beneath the siding on the lower mid-right side of the home -see example picture 4 below. All excess house wrap should be removed. (E.) Sealant is lacking around the HVAC condensate drain pipes at the lower right side -see pictures 4, 5 & 6 below. Sealant should be applied where needed. (E.) Debris was noted in the upper wall hood on the right side of the home -see picture 7 below. The debris should be removed and hood confirmed functional. (F.) Paint over-spray was noted on the first floor front porch window -see example picture 8 below. All excessive paint should be removed without damaging the window or the damaged window materials should be replaced.

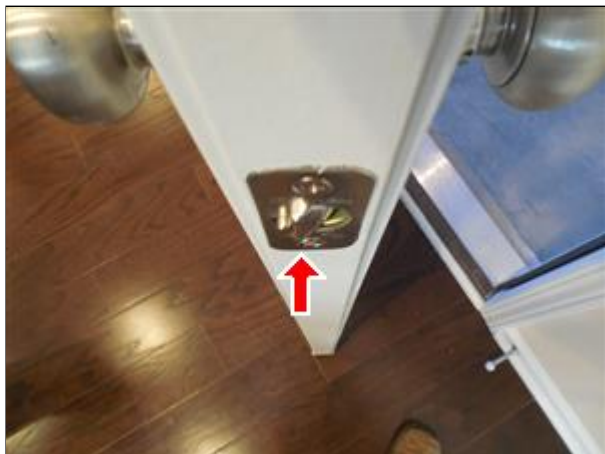
2.1 Picture 1

**Repair** The following exterior door defects were noted: (A.) The plunger on the door latch of the entry door from the garage sticks into the door during operation -see picture 1 below. Repair as needed. (B.) The exterior wood kick plate beneath the rear sliding glass door is damaged, crooked and does not adequately support the threshold -see example pictures 2 & 3 below. The kick plate should be replaced, secured, primed and painted. (C.) The exterior wood kick plate beneath the entry door into the exterior rear utility room is installed at an angle and not adequately secured -see picture 4 below. Properly re-install and secure or replace, secure, prime and paint. (D.) There are excessive gaps between the threshold and the bottom of the front entry door -see example picture 5 below. To maintain energy efficiency the gaps should be eliminated. (E.) The interior door knob is damaged on the front entry door into the home -see picture 6 below. The door knob should be replaced.

🏠 2.1 Repair The following exterior door defects were noted: (A.) The plunger on the door latch of the entry door from the garage sticks into the door during operation -see picture 1 below. Repair as needed. (B.) The exterior wood kick plate beneath the rear sliding glass door is damaged, crooked and does not adequately support the threshold -see example pictures 2 & 3 below. The kick plate should be replaced, secured, primed and painted. (C.) The exterior wood kick plate beneath the entry door into the exterior rear utility room is installed at an angle and not adequately secured -see picture 4 below. Properly re-install and secure or replace, secure, prime and paint. (D.) There are excessive gaps between the threshold and the bottom of the front entry door -see example picture 5 below. To maintain energy efficiency the gaps should be eliminated. (E.) The interior door knob is damaged on the front entry door into the home -see picture 6 below. The door knob should be replaced.

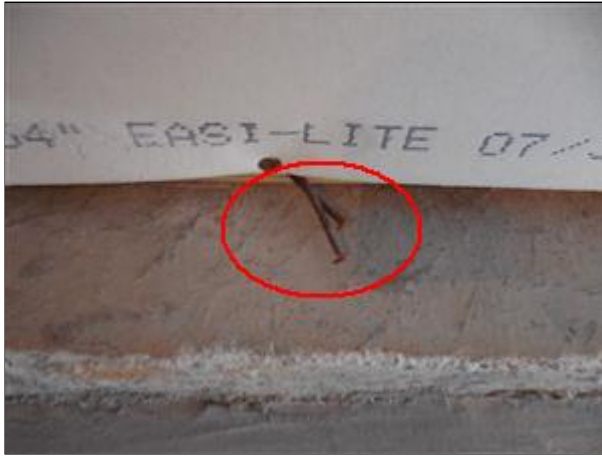
3.1 Picture 1

**Repair** The following garage wall defects were noted: (A.) Nails were noted protruding from the mid-base of the right garage wall -see picture 1 below. The nails should be removed and any voids filled and sealed. (B.) The caulk is failing at the exterior door trim/wall connections of the entry door from the garage -see picture 2 below. The caulk should be renewed where needed.

3.1 Repair The following garage wall defects were noted: (A.) Nails were noted protruding from the mid-base of the right garage wall -see picture 1 below. The nails should be removed and any voids filled and sealed. (B.) The caulk is failing at the exterior door trim/wall connections of the entry door from the garage -see picture 2 below. The caulk should be renewed where needed.

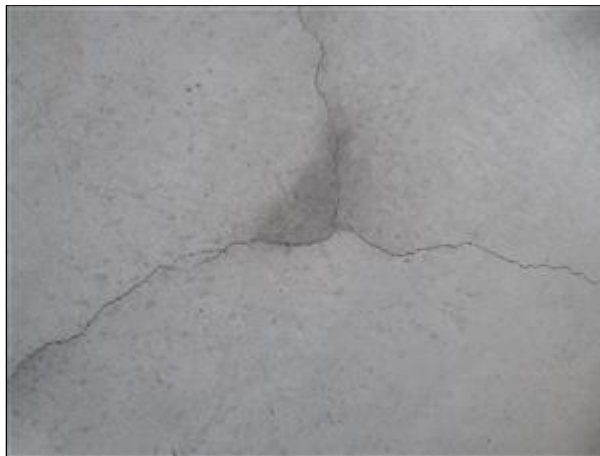
3.6 Picture 1

3.6 Comment Cracks in the poured concrete foundation slab of the garage were noted -see example picture 1 below. These cracks are less than a quarter of an inch in width and are not pitching and heaving. These cracks do not appear to require repair for functional purposes and in most cases cracks such as these are stable and do not significantly change once a house has reached this age. In all cases I can not predict nor guarantee against future changes which might require repair. Consult the builder for possible repair options.

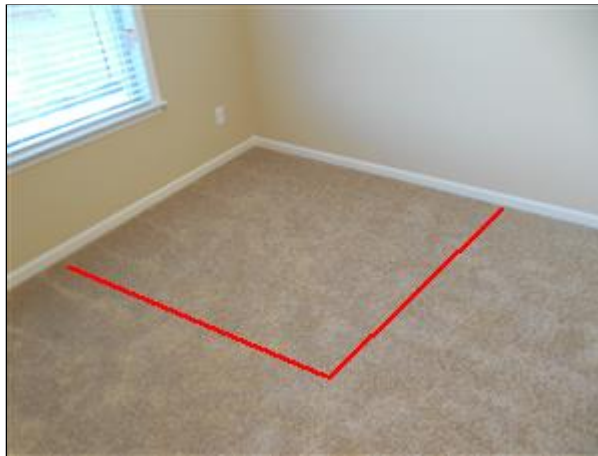
4.2 Picture 1

**Repair** The subflooring/flooring is raised at the left front of the second floor left front bedroom -see picture 1 below. The source of the raised flooring should be determined and corrected as needed. All damaged flooring materials discovered and/or incurred during the repair should be replaced in their entirety.

4.2 Repair The subflooring/flooring is raised at the left front of the second floor left front bedroom -see picture 1 below. The source of the raised flooring should be determined and corrected as needed. All damaged flooring materials discovered and/or incurred during the repair should be replaced in their entirety.

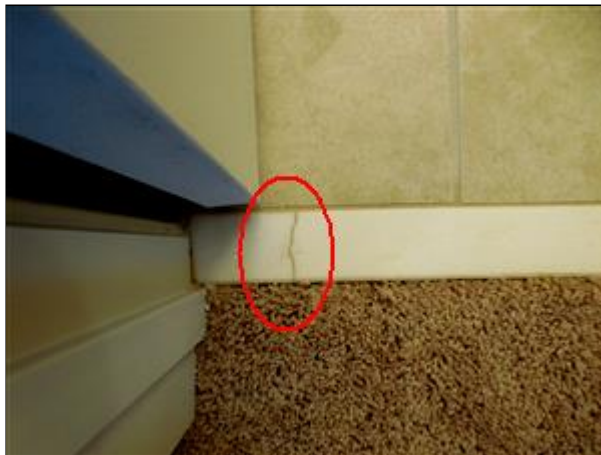
4.5 Picture 1

**Repair** The following interior door defects were noted: (A.) The threshold is damaged on the second floor hall bathroom entry door -see picture 1 below. All damaged materials should be replaced in their entirety. (B.) The hinge pin is missing on the center hinge on the master bathroom entry door -see picture 2 below. The pin or the entire hinge should be replaced. (C.) The master bedroom entry door does not latch when closed. Repair as needed.

4.5 Repair The following interior door defects were noted: (A.) The threshold is damaged on the second floor hall bathroom entry door -see picture 1 below. All damaged materials should be replaced in their entirety. (B.) The hinge pin is missing on the center hinge on the master bathroom entry door -see picture 2 below. The pin or the entire hinge should be replaced. (C.) The master bedroom entry door does not latch when closed. Repair as needed.

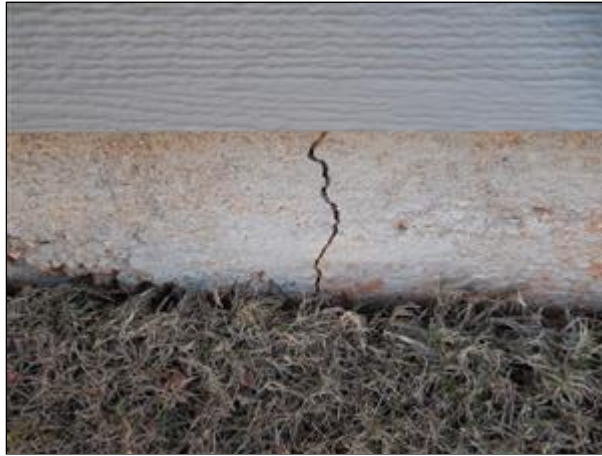
5.0 Picture 1

5.0 Comment Cracks were noted in the poured concrete slab foundation -see example picture 1 below. These cracks do not appear to require repair for functional purposes. In most cases cracks such as these are stable and do not significantly change once a house has reached this age. In all cases I can not predict nor guarantee against future changes which might require repair. Consult the builder for more information.

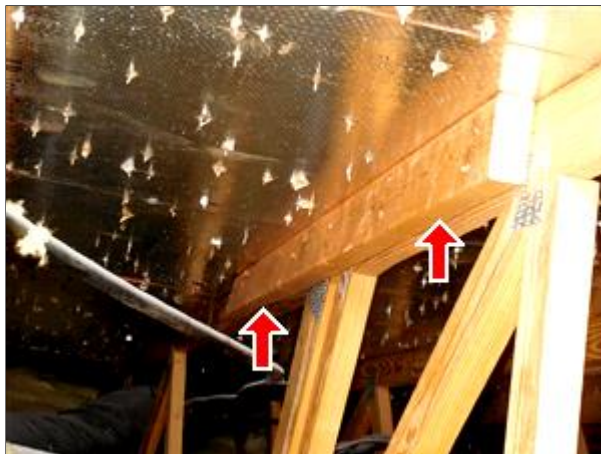
5.5 Picture 1

**Investigate Further** Manufactured roof trusses have been installed to support the roof and multi-sectional roof trusses were noted at the rear of the home as viewed from the attic area. The majority of the multi-sectional roof trusses at the rear of the home have been adjoined or "sistered" at the truss cord connections -see example picture 1 below, however at least two of the multi-sectional roof trusses at the rear of the home are not sistered, of particular note at the right rear -see example picture 2 below. The attic trusses, especially the un-sistered rear trusses should be further evaluated by the builder and repaired as needed. Note: Any repairs or modifications to manufactured trusses are required to be further evaluated by a licensed Structural Engineer experienced in such defects. All repairs stipulated in the licensed Structural Engineer's Report should be performed by a licensed contractor with knowledge and experience performing such repairs.

5.5 Investigate Further Manufactured roof trusses have been installed to support the roof and multi-sectional roof trusses were noted at the rear of the home as viewed from the attic area. The majority of the multi-sectional roof trusses at the rear of the home have been adjoined or "sistered" at the truss cord connections -see example picture 1 below, however at least two of the multi-sectional roof trusses at the rear of the home are not sistered, of particular note at the right rear - see example picture 2 below. The attic trusses, especially the un-sistered rear trusses should be further evaluated by the builder and repaired as needed. Note: Any repairs or modifications to manufactured trusses are required to be further evaluated by a licensed Structural Engineer experienced in such defects. All repairs stipulated in the licensed Structural Engineer's Report should be performed by a licensed contractor with knowledge and experience performing such repairs.

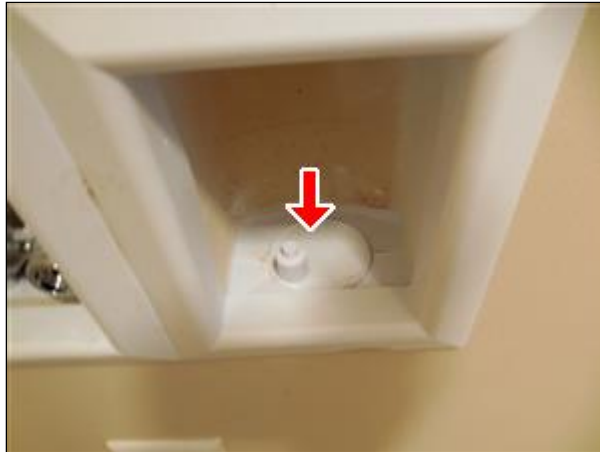
6.0 Picture 1

**Repair** The drain cap is still installed on the washing machine drain -see picture 1 below. The drain cap should be removed.

6.0 Repair The drain cap is still installed on the washing machine drain -see picture 1 below. The drain cap should be removed.

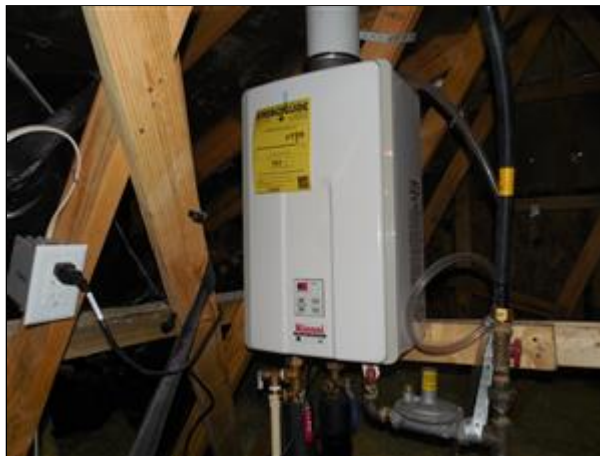
6.2 Picture 1

6.2 Comment The temperature of the hot water could not be determined due to the water supply being off at the time of inspection. The water heater is located in the attic area -see picture 1 below.

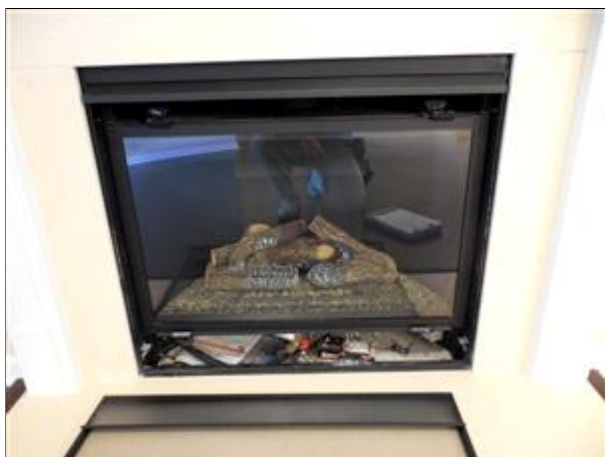
8.6 Picture 1

**Investigate Further** The following observations were noted with the gas log fireplace -see picture 1 below: (A.) There are open voids in the lower front access area of the gas log fireplace, of particular note around the gas line that services the fireplace at the mid-left side of the bottom access area -see picture 2 below. These voids/gaps are allowing for unconditioned air to enter the home via the voids/gaps. To assist in maintaining the energy efficiency of the home, these voids/gaps should be properly sealed with the appropriate material. (B.) The gas logs did not function at the time of inspection there for the gas logs and all their related functions and features could not be

8.6 Investigate Further The following observations were noted with the gas log fireplace -see picture 1 below: (A.) There are open voids in the lower front access area of the gas log fireplace, of particular note around the gas line that services the fireplace at the mid-left side of the bottom access area -see picture 2 below. These voids/gaps are allowing for unconditioned air to enter the home via the voids/gaps. To assist in maintaining the energy efficiency of the home, these voids/gaps should be properly sealed with the appropriate material. (B.) The gas logs did not function at the time of inspection there for the gas logs and all their related functions and features could not be properly inspected or tested. This should be done once the gas logs are made functional and its functions and features explained and demonstrated to the buyers.

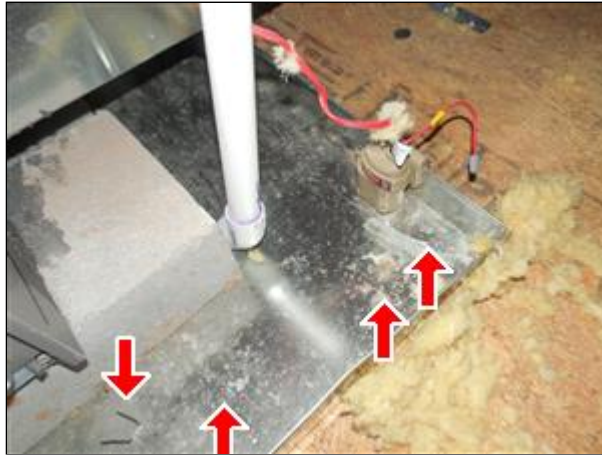
8.7 Picture 1

(1) **Repair** Blown fiberglass insulation and debris was noted in the emergency condensate overflow pan below the HVAC air handler in the attic -see example picture 1 below. This can cause the pan drain and/or air conditioning system emergency cut off switch on the pan to malfunction at the time of need. All blown insulation and debris should be removed from the pan.

8.7 (1) Repair Blown fiberglass insulation and debris was noted in the emergency condensate overflow pan below the HVAC air handler in the attic -see example picture 1 below. This can cause the pan drain and/or air conditioning system emergency cut off switch on the pan to malfunction at the time of need. All blown insulation and debris should be removed from the pan.

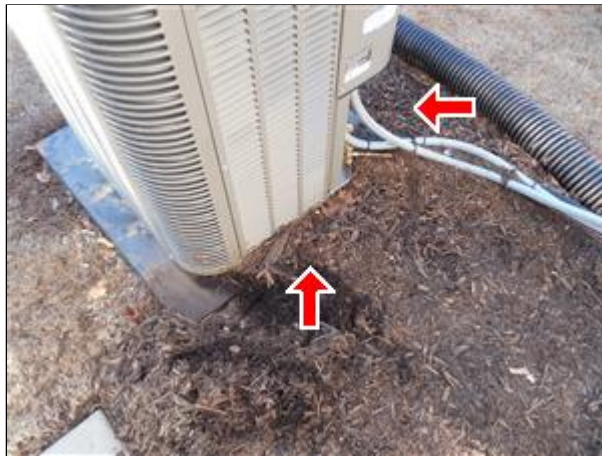
8.7 Picture 2

(3) **Maintenance** Mulch and debris should be cleared away from the air conditioning condensing unit and the platform the unit sits on to assist in preventing corrosion, keeping the exterior cooling coils clean and to allow for proper cooling of the warm refrigerant coils within the condenser -see picture 2 below.

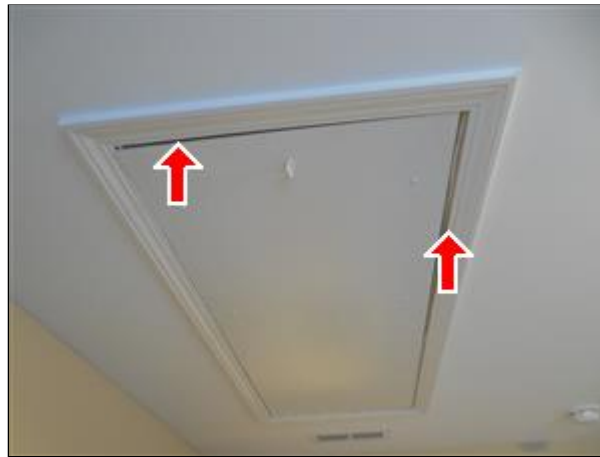
9.0 Picture 1

Repair The attic entry door does is installed crooked and does not fit flush against the door jamb allowing for the loss of conditioned interior air via the gaps -see picture 1 below. The door should be properly repaired or replaced if needed.

9.0 Repair The attic entry door does is installed crooked and does not fit flush against the door jamb allowing for the loss of conditioned interior air via the gaps -see picture 1 below. The door should be properly repaired or replaced if needed.

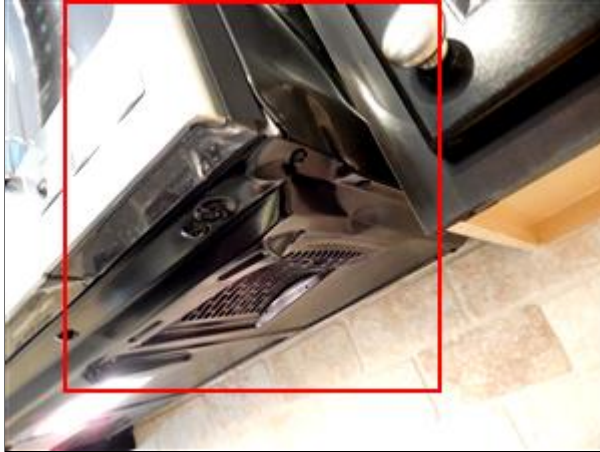
10.4 Picture 1

Repair The following microwave defects were noted: (A.) The case of the microwave is excessively damaged on the lower front right side -see picture 1 below. (B.) The stove vent hood compartment on the front right base of the microwave is damaged and the vent screen is missing -see picture 2 below. The microwave should be replaced.

**10.4 Repair** The following microwave defects were noted: (A.) The case of the microwave is excessively damaged on the lower front right side -see picture 1 below. (B.) The stove vent hood compartment on the front right base of the microwave is damaged and the vent screen is missing -see picture 2 below. The microwave should be replaced.
