Inspection Report

Property Address:
Sample Report
Raleigh NC 27614

The _____ Residence

Jeff Pinyoun Residential & Commercial Inspections

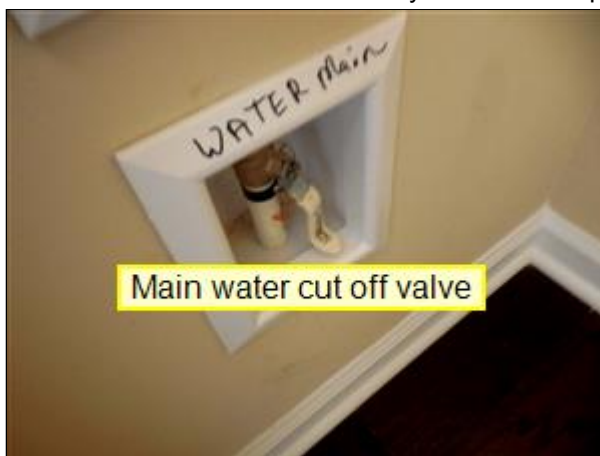
6.3 Picture 1

6.3 Comment The main water cut off valve is located in the front foyer closet -see picture 1 below.

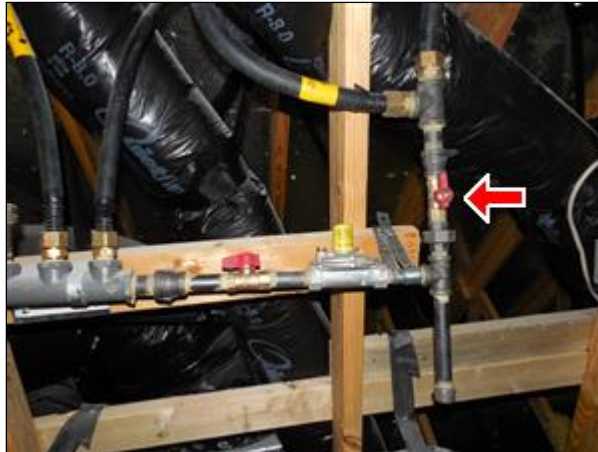
6.5 Picture 1

6.5 Comment The main natural gas fuel shut off valves are located at the natural gas meter outside and at the regulator/gas lines connection area in the attic area -see picture 1 below.

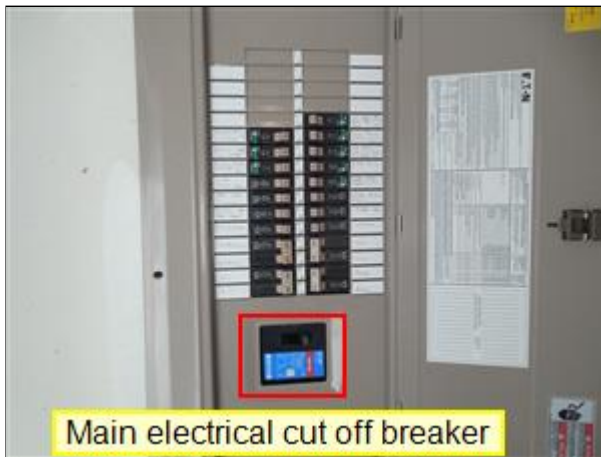
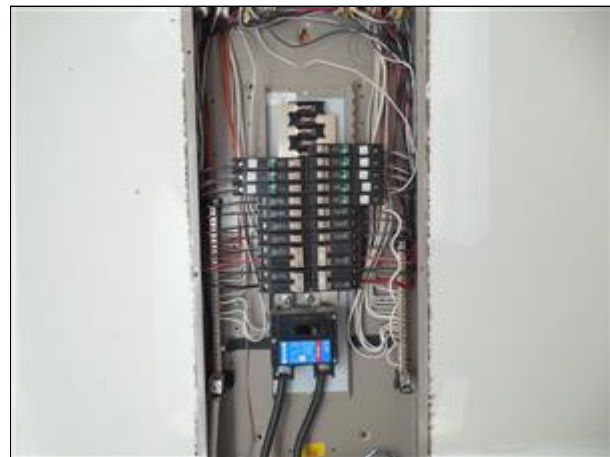
7.1 Comment The main electrical cut off breaker for the entire home is located in the electrical panel box in the rear exterior utility room -see pictures 1 & 2 below

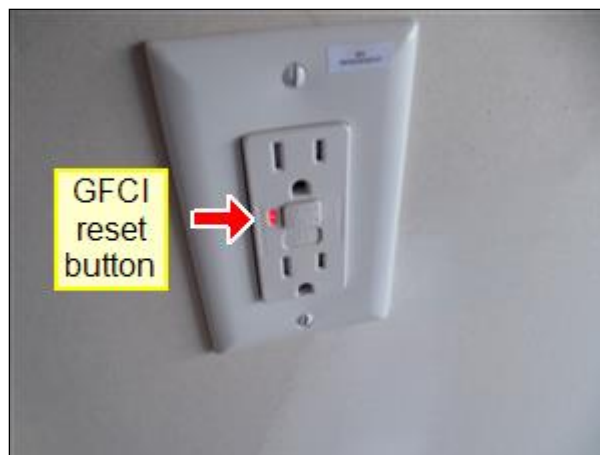
7.9 Picture 1

7.9 (1) Comment The following GFCI receptacles control the following electrical circuits: (A.) The GFCI reset button for all of the exterior and garage electrical receptacles is located on the receptacle on the right wall of the garage and at the rear patio -see picture 1 below. (B.) All of the bathrooms electrical receptacles are controlled by the GFCI receptacle in the master bathroom.

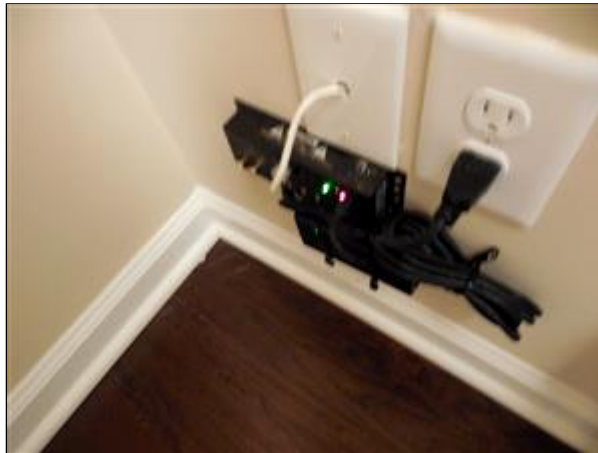
7.9 Picture 2

(2) **Comment** The low voltage systems were not inspected or tested as this is not considered part of a normal home inspection -see picture 1 below. Consult the builder and/or the providers for any documents and demonstrations.

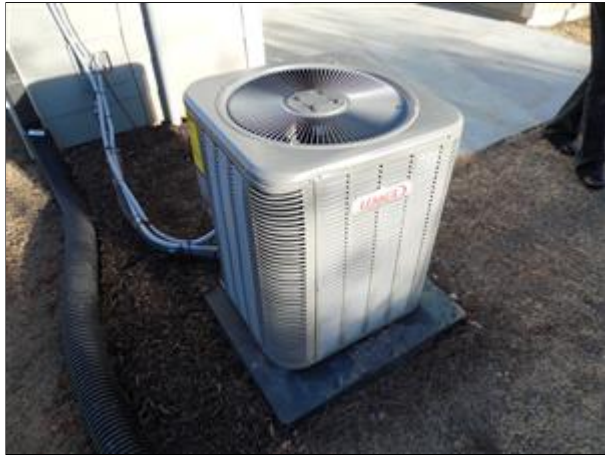
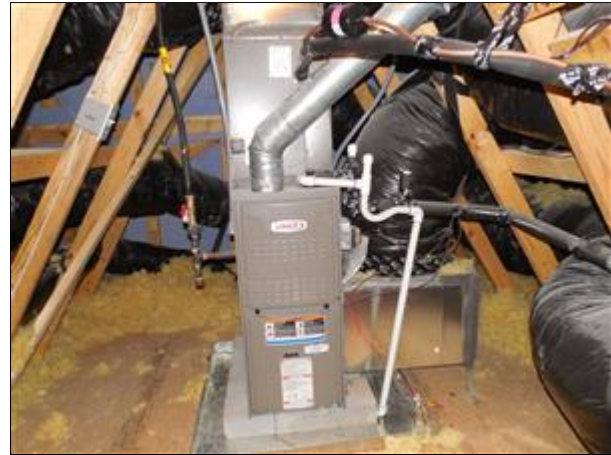
8.10 (1) Comment Per coded information on the HVAC system, it appears to be: One 2014 Lennox 2 & 1/2 Ton -see pictures 1 & 2 below.

Compressor Model # 13ACX-030-17 Serial # 1914K20670

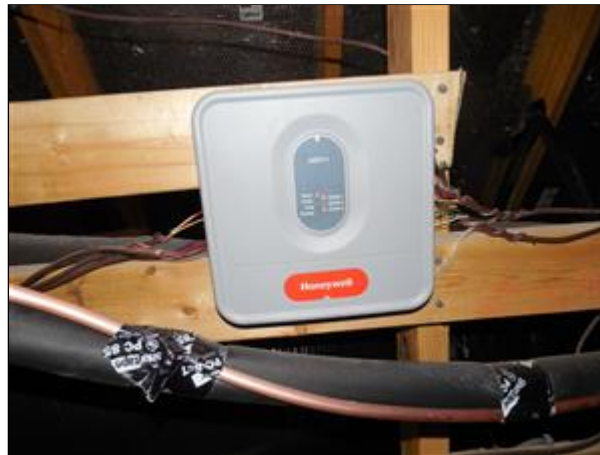
8.10 Picture 3

(2) **Comment** The home has two floors with two thermostats and only one HVAC system. The electronic circuit board located in the attic area electronically balances the amount of conditioned air flow to the two floors depending on the settings of the first and second floor thermostats by the use of electronic motor operated dampers -see picture 3 below.
